City of Winchester, VA Traffic Signal Upgrade Project

Keith Riniker, PE, PTOE, Perry Eisenach, PE, Thomas Hannan, PE, PTOE

I. Abstract

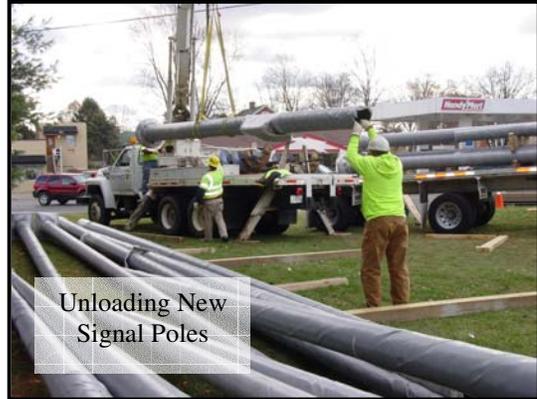
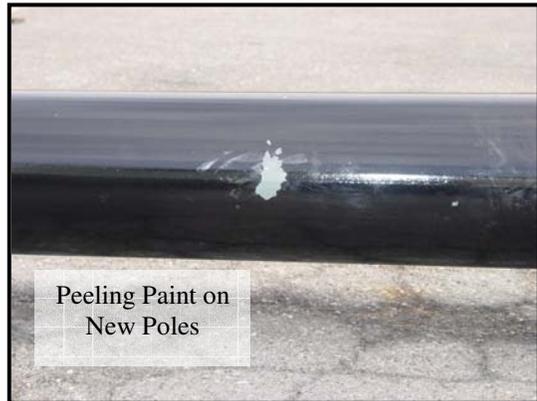
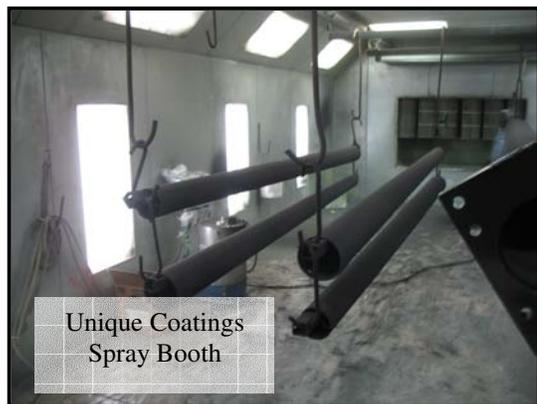
The following describes the process that Unique Coatings following to repair the poles. All poles were "sand" blasted ("profiled") with engineered plastic shot. The profiling and preparation process took about 8 to 12 hours for each upright mast arm pole, and about 5 to 9 hours for each mast arm, depending on the length. The poles were then cleaned and heated to 400-degrees F, then cooled slightly in a spray booth and shot with the primer coat using an electrostatic, powder spray gun. Primed poles were baked in the oven a second time to set the primer coat, and afterwards again returned to the spray booth for the

application of the finish coat. Finally, the finish coated pole is returned to the oven a third time to set the two coatings and the pole surface together.

The poles were delivered to the site, wrapped to avoid damage, and carefully unloaded. The signal contractor subsequently installed the poles. After installation at a few intersections, the City noticed air bubbles and paint peeling off of the poles. The following week, the manufacturer's representative visited the site and agreed there was a problem with the coating process. The poles were taken down and shipped to Unique Coatings in High Point, NC for repair.

The problem was that the pole manufacturer did not follow the powder coating system manufacturer's specific instructions, and the preparation of the galvanized poles were not to be compatible with the application of the powder coating system.
